Docket No. 217 – Development and Management Plan Inspection

Northeast Utilities Service Company Certificate of Environmental Compatibility and Public Need for the construction of a 345-kV electric transmission line and reconstruction of an existing 115-kV electric transmission line between Connecticut Light and Power Company's Plumtree Substation in Bethel, through the towns of Redding, Weston, and Wilton, and to the Norwalk Substation in Norwalk, Connecticut.

Date: September 21, 2005

Location: Transition Stations (Hoyts Hill, Archers Lane)

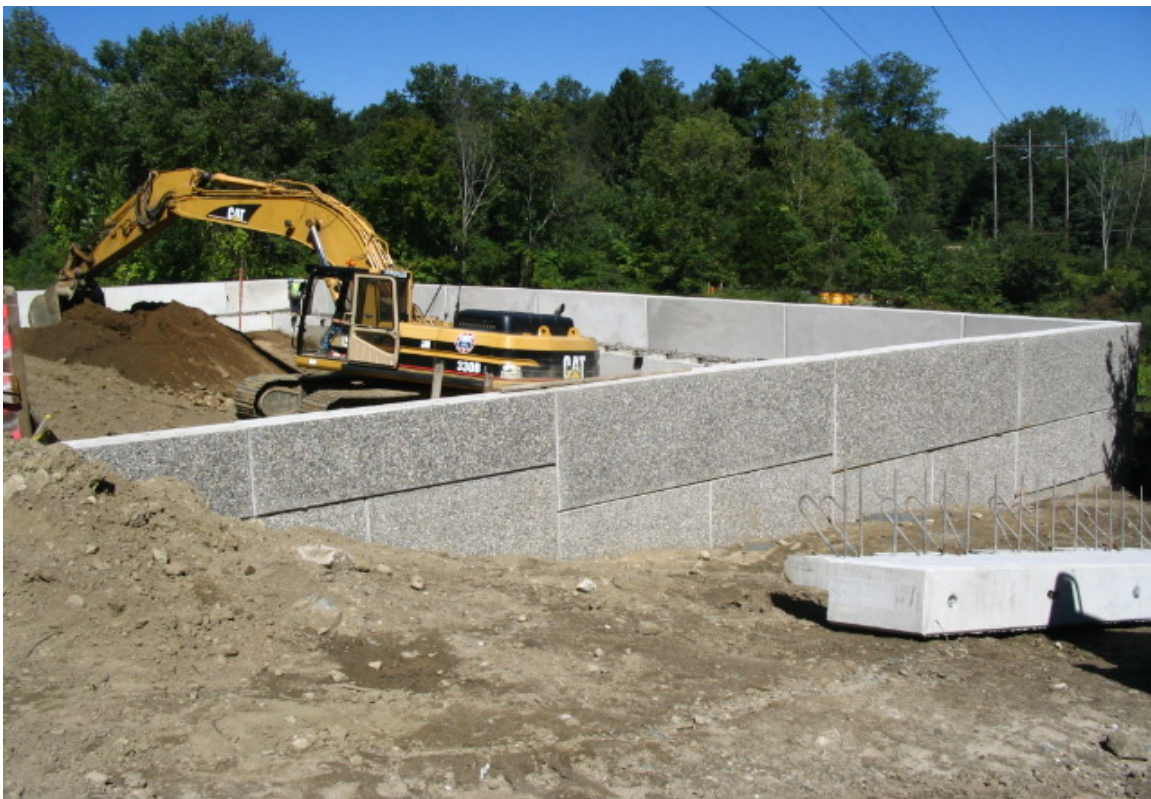
Hoyts Hill Transition Station: View of the ongoing construction of the retaining walls and infrastructure of the station. (9/21/05)

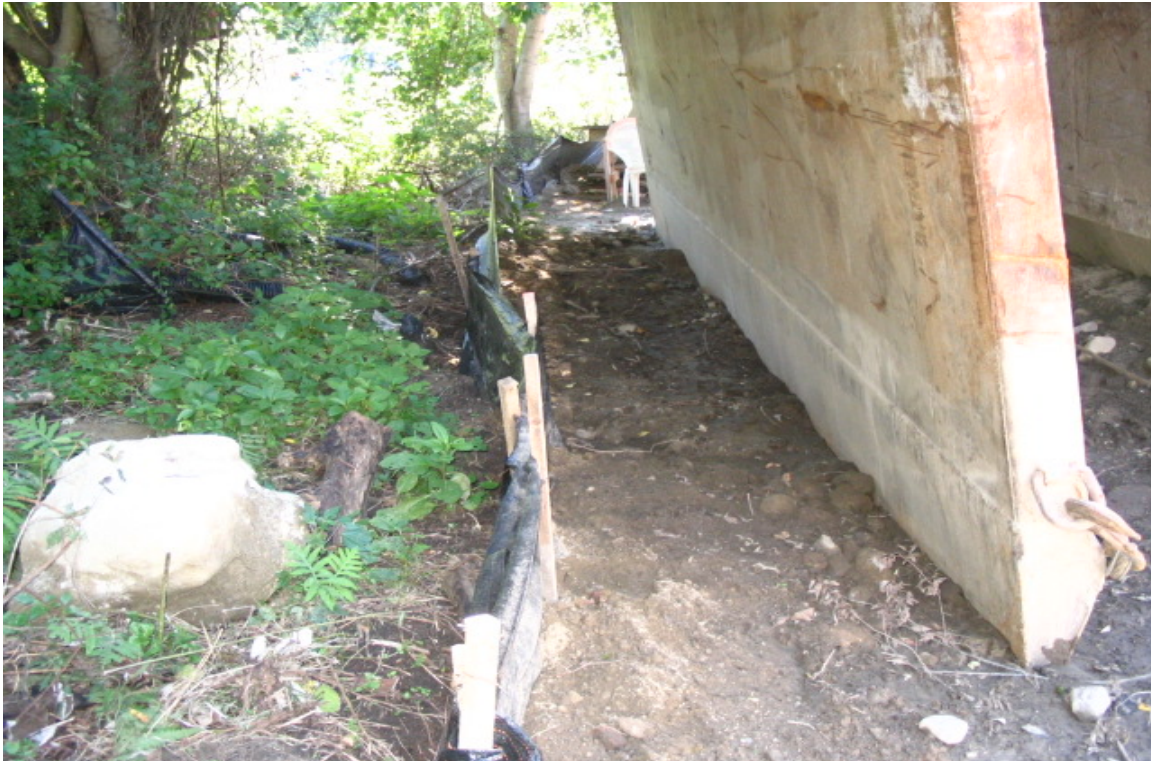
The silt fence along the southern side of the site has been repaired as recommended and all erosion controls remain in good shape. (9/21/05)

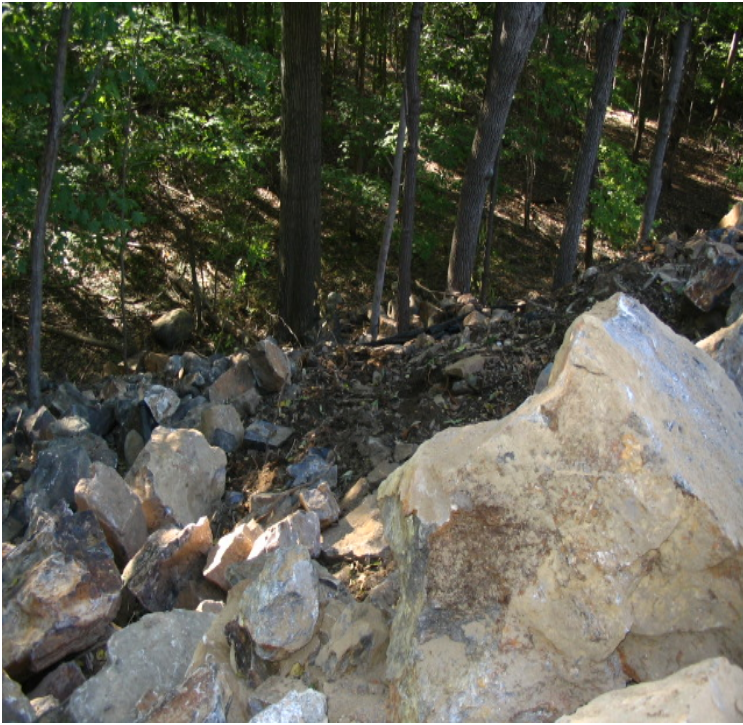
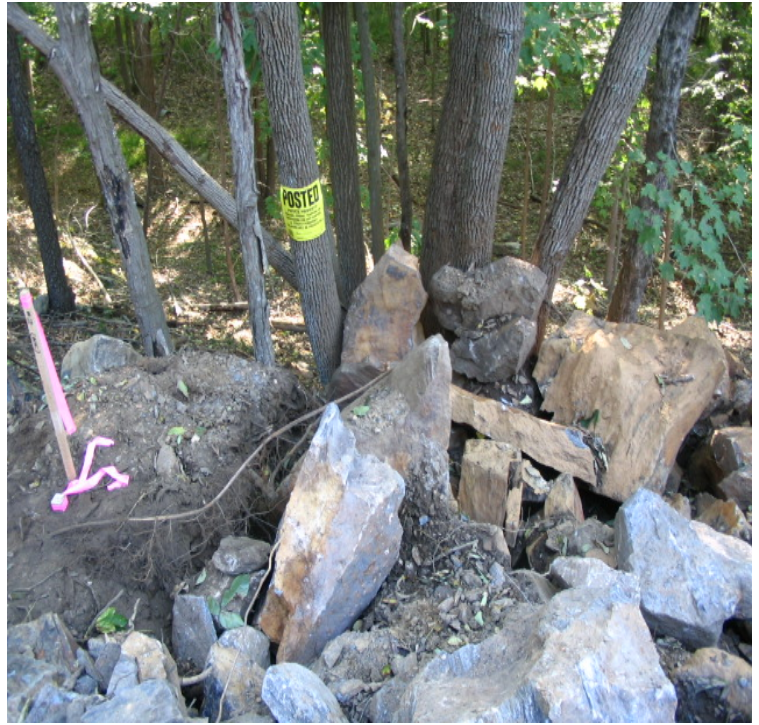
Archers Lane Transition Station: Both photos show views of the some of the materials that ended up at the property line following some blasting. Materials will be removed when permission is obtained. (9/21/05)

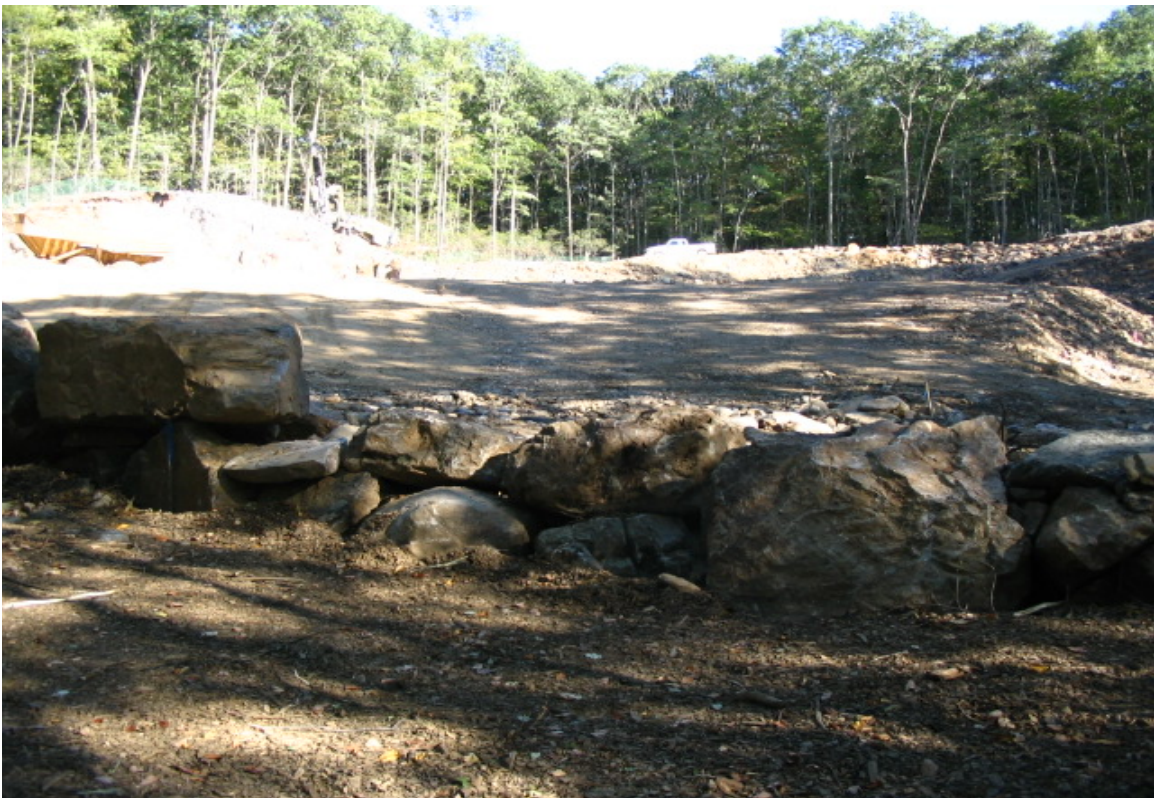
Overall view of the station site following some blasting and earthwork. (9/21/05)

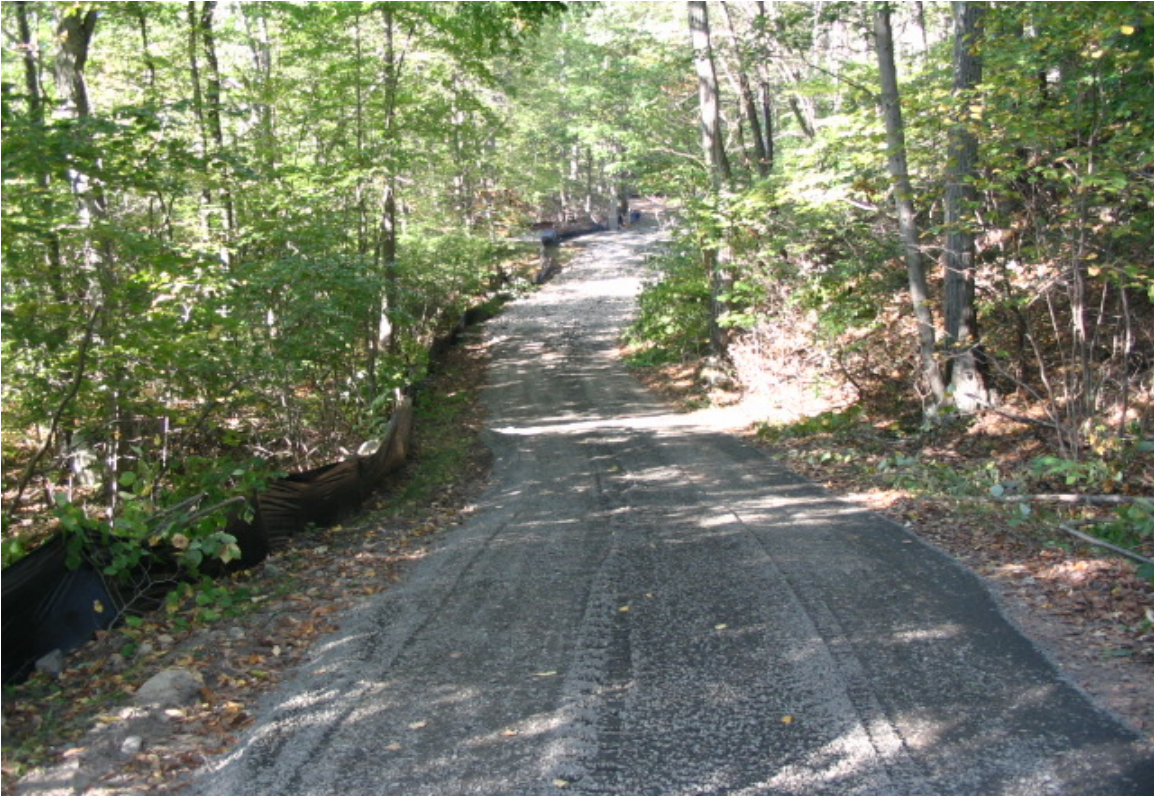
View of the access road for the overhead ROW which had previously been used for the station site. Stone dust was installed along the road to create improved access. (9/21/05)

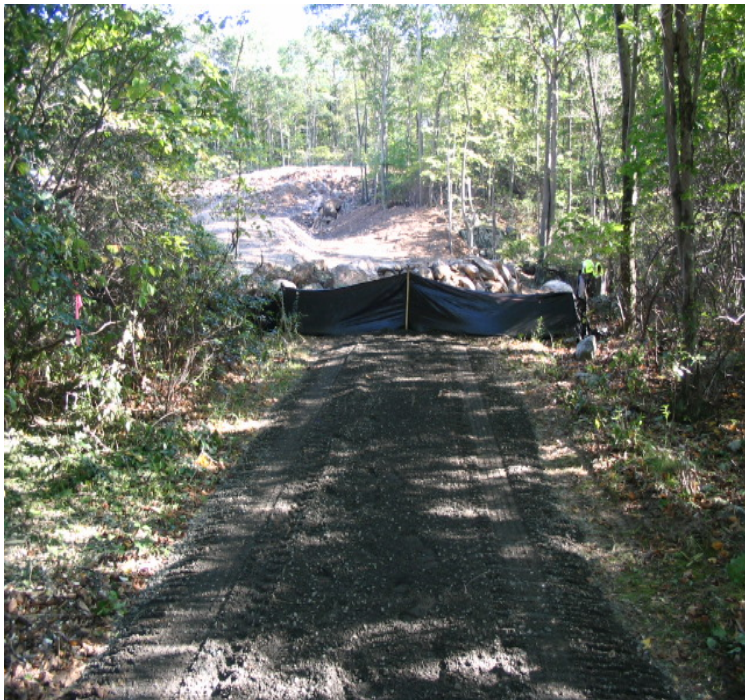
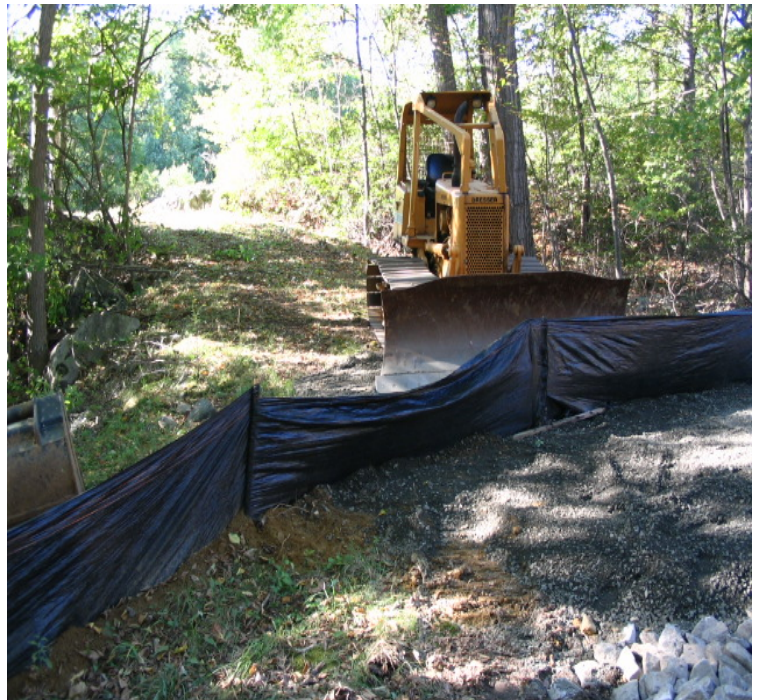
Photo on the left shows a view into the transition station from the access into the ROW. Photo on the right shows another access point to the ROW. Both spots will be placed with haybales to be moved for access to the ROW and will be the responsibility of that portion of the project. 9/21/05
